December 2, 2020

Village of Arden Forest Committee
Ms. Carol Larson
2119 The Highway
Wilmington, DE 19810-4058

Subject: White pine assessment; Arden Green

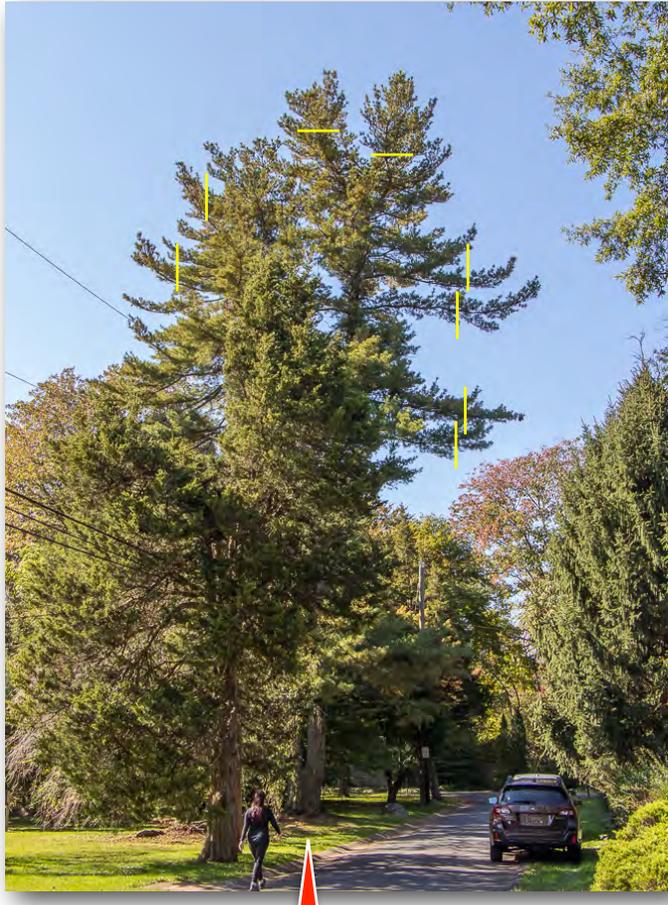
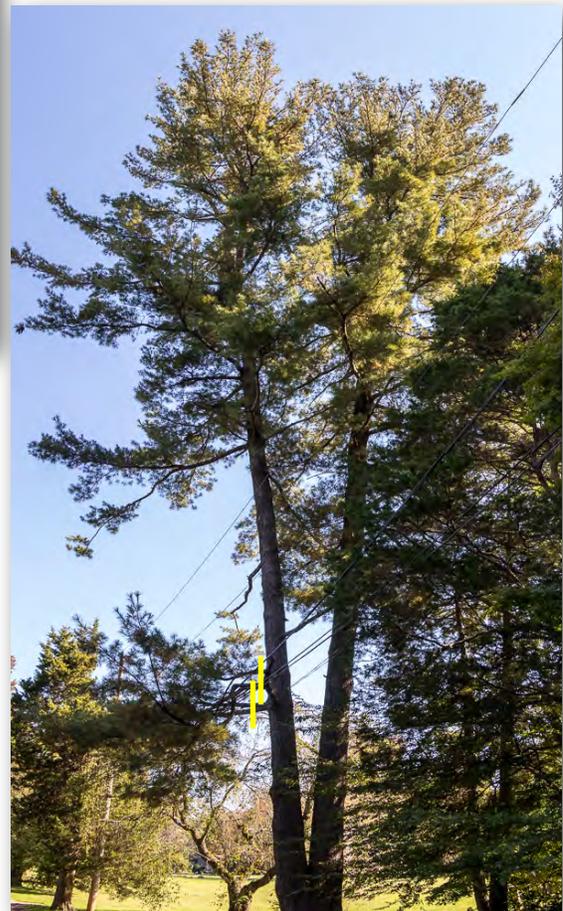
The tree is an eastern white pine (*Pinus strobus*), located near the edge of Woodland Lane (Figures 1 and 2). It is within Arden Green, next to the stone maze and near the playground area. The tree bifurcates at about 4.5 feet above the ground into two main trunks. These trunks measure 21 and 23 inches in diameter, at one foot above the main crotch. The smaller stem (Trunk #1) is closest to Woodland Lane and leans slightly to the northwest toward the road. Electric and communications utility wires run alongside Woodland Lane and pass within about 3 feet of the trunk.

Figures 1 and 2: The white pine is growing close to Woodland Lane (red arrow points to base). It has two main trunks, with the top of the main crotch at about 4.5 feet above the ground. Electric and communications wires run under the tree's crown within less than 3 feet from the nearest trunk.

The first step is some light pruning of the crown of the tree to slightly reduce the height, weight, and resistance to wind. The pruning reduces the stresses placed on the tree by wind and gravity, thereby reducing the risk of failure. Pruning should be done to remove no more than 8 to 10 feet of any branch, and no pruning cuts should exceed about 1.5 inch diameter branches. The pruning only need be done on the upper portion of the crown, except for a few lower branches that extend beyond the average crown limit. Several low branches that extend between or close to the communication wires and over the road can be removed entirely. Figures 1 and 2 include markers to indicate suggested pruning points and branch removals.

The short yellow lines indicate suggested branches and locations for light pruning. It is not necessary to make larger cuts to accomplish the desired reduction. The lines on Figure 2 show the low branches to be removed to clear the low wires.

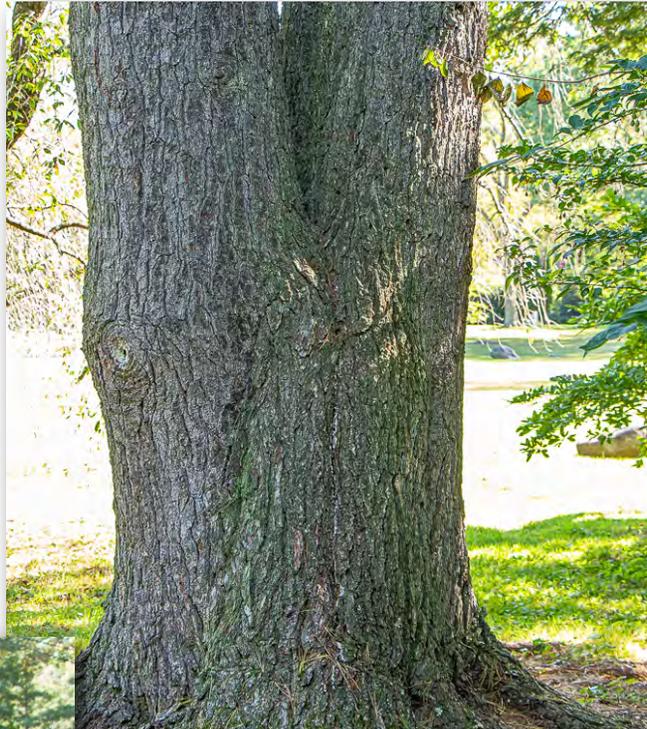
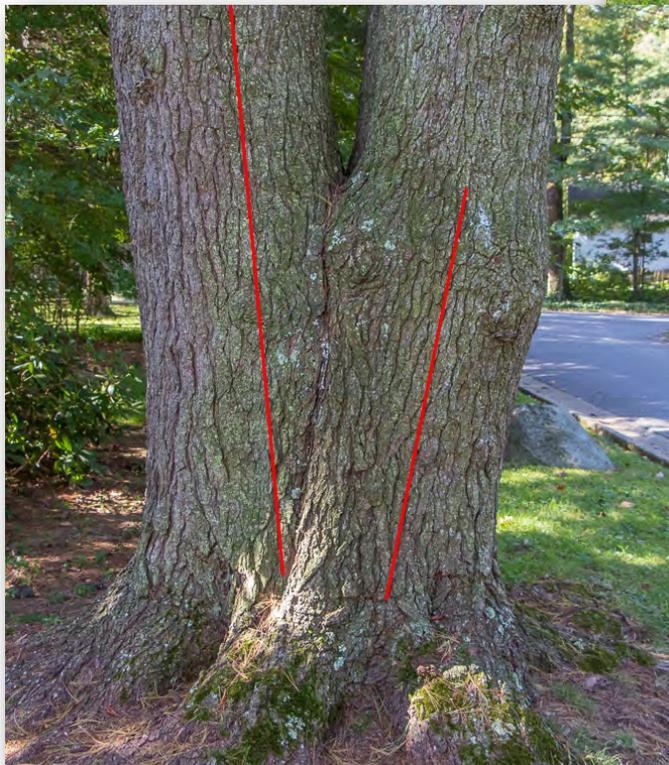
The main concern for this tree is its structural integrity. The main crotch between the two stems has a seam and ridge down both sides, extending to the ground (Figures 3 and 4). The seams are occluded by bark, but the wood may not be fused. I did not see clear evidence of actual spreading of the seam, however.

The area between the trunks, at the top of the crotch, has an opening about 2 to 3 inches wide. This represents a vascular-supply shadow, an area where the flow of sap is reduced to normal growth of the tree

Figures 3 and 4: The crotch near the base is the result of the two trunks growing close together. A closed seam runs down each side, indicating that the wood of the trunks may not be fused between them. At the top of the crotch between the trunks is an opening to the internal cavity.

The red lines in Figure 4 below indicate the approximate location of the piths or 'centers' of the trunks. The trunks grew up from either two seeds or two leaders from a single seed.

The second option to further reduce the risk of crotch failure is the installation of a support system between the two trunks, high in the crown. The support system should be placed 15 feet above the topmost electric wire. Two types of system are commonly used: a flexible synthetic fabric that is looped loosely around the main trunks, and a steel cable system. The latter system requires drilling through the trunks and installing steel eyebolts, then attaching a high-strength steel cable between the bolts. I recommend using the flexible system, although either can be used. The reasons for the flexible system are concerned with safety during installation above the electric wires, and a reduced risk of damage to the trees in the case of a lightning strike, again because of the nearby wires.

My recommendation for now is that the tree be pruned and a crown support system be installed. The amount of decay and stability of the base is not yet at a level that stem bolts are needed. These can be added in the future if warranted.

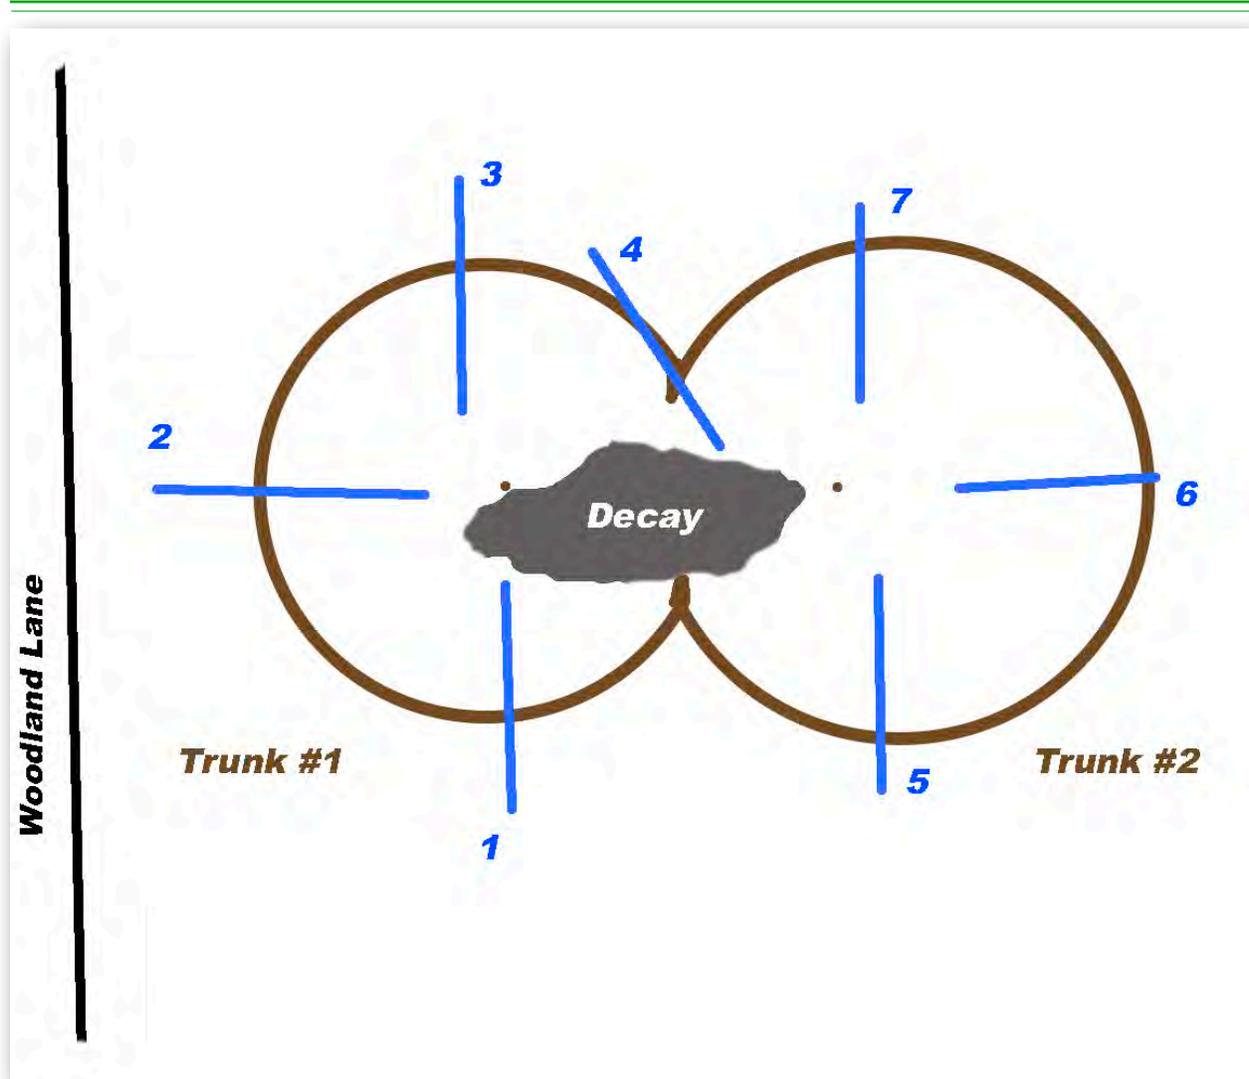
I tested the trunks about 8 to 14 inches below the top of the crotch, making a total of seven test borings: 4 tests into Trunk #1, and 3 tests in Trunk #2 (Figure 5). The resulting test strips are attached (Figures 6 and 7). These boring results are read from right to left, with zero resistance at the bottom and higher resistance toward the top. There are no specific measurements of pressure or resistance associate with these tests: the results are interpreted as the relative trends as the probe moves deeper into the wood. The maximum effective depth of the tests with this unit is 11.5 inches.

Of the seven test borings, only #1 showed indications of internal decay. This decay was at a depth of 7.5 inches from the beginning of solid wood under the bark. All other borings showed solid wood to the full depth of the probe. The probe depth was equal to or greater than half the diameter of either trunk.

Analysis of the test results indicate that the loss of strength due to the internal decay and the seams is still well below accepted thresholds. Trunk #1 (closest to road) has an estimated strength loss of less than 15 percent: the threshold is at least a 30 percent loss before the risk is considered of concern. Trunk #2 did not show any decay in the boring tests, although there is some decay associated with the crotch.

Figure 5: This diagram indicates the configuration of the two trunks looking down from above. The blue lines represent the locations of the test boring sites at about 4 feet above the ground. Each test site went to 11.5 inches deep from the outer bark. Only test site #1 encountered any decay. The dark grey area indicates the probable area of decay at this level in the tree. Lower on the trunk the decay probably spreads a bit wider, but still within the safety parameters.

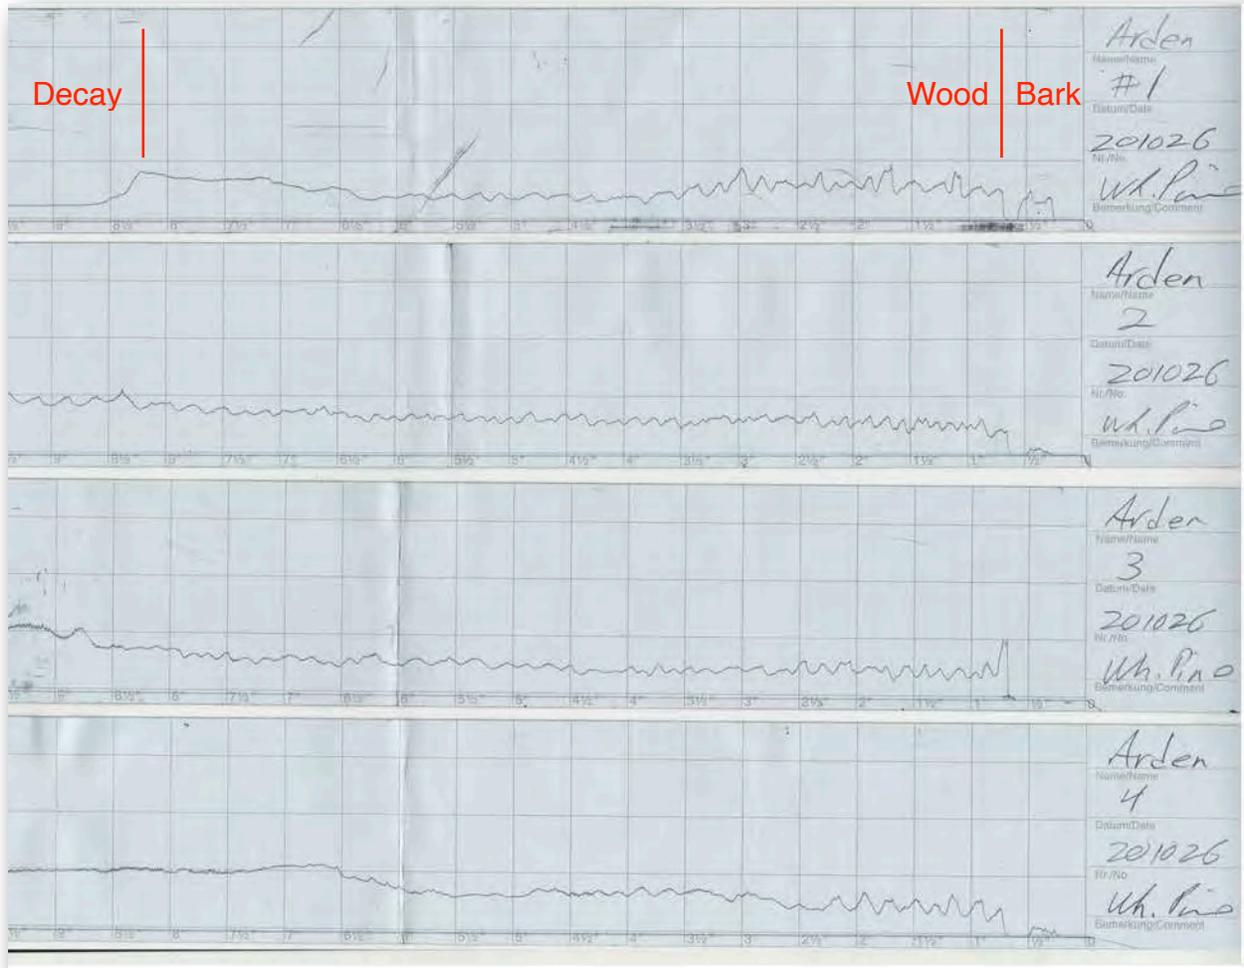
Figure 6: These are scans of the Resi probe traces for tests 1 through 4. The traces is read from right to left along the bottom. Level or upward trends indicate solid wood, sudden drops indicate lower resistance, representing decay. In trace #1, the decay shows up at about 7.5 inches from the beginning of solid wood. (All traces were continued to 11.5 inches from the start point, but were truncated due to scanning equipment limitations.)

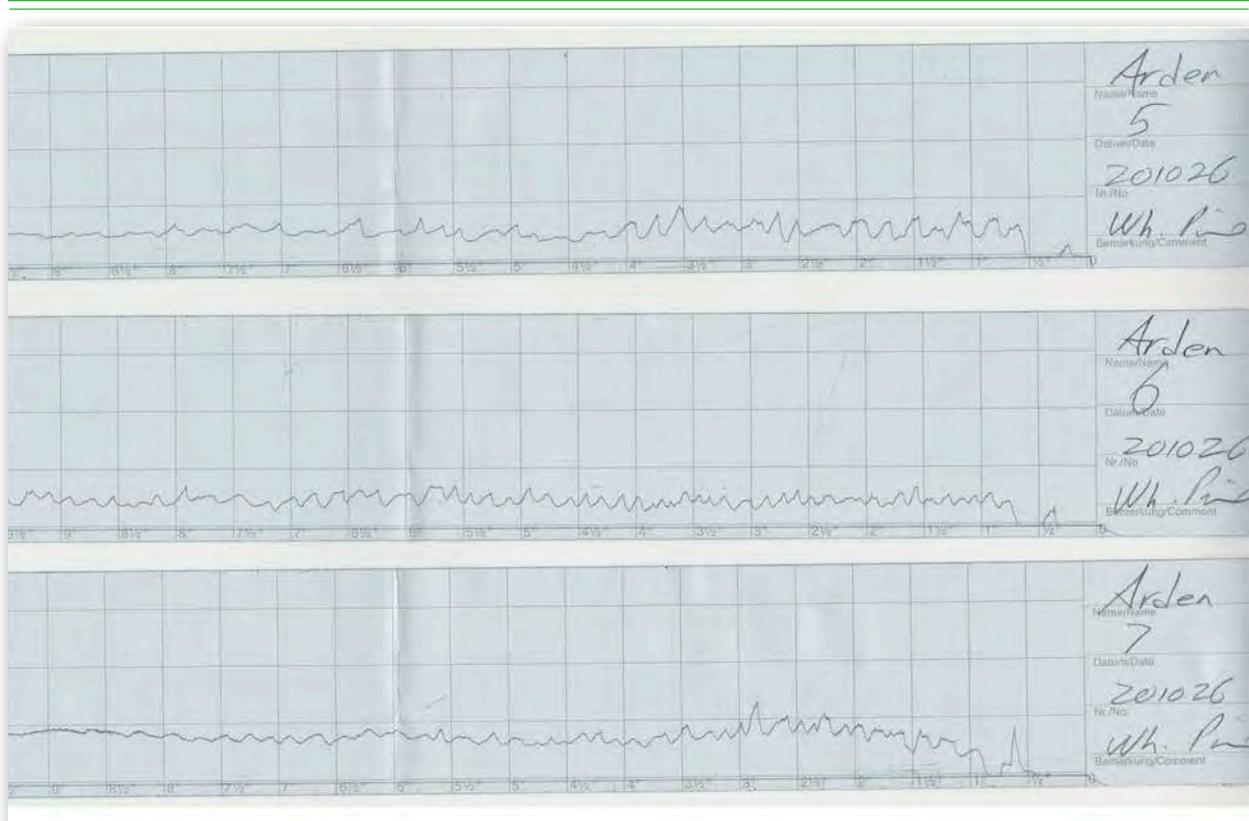
Figure 7: These are scans of the Resi probe traces for tests 5 through 7. See description for Figure 6.
